Service Bulletin

Rudder cable clearance on Cessna 206H, T206H equipped with Kelly Aerospace Thermal Systems Air Conditioning per STC SA03302CH.

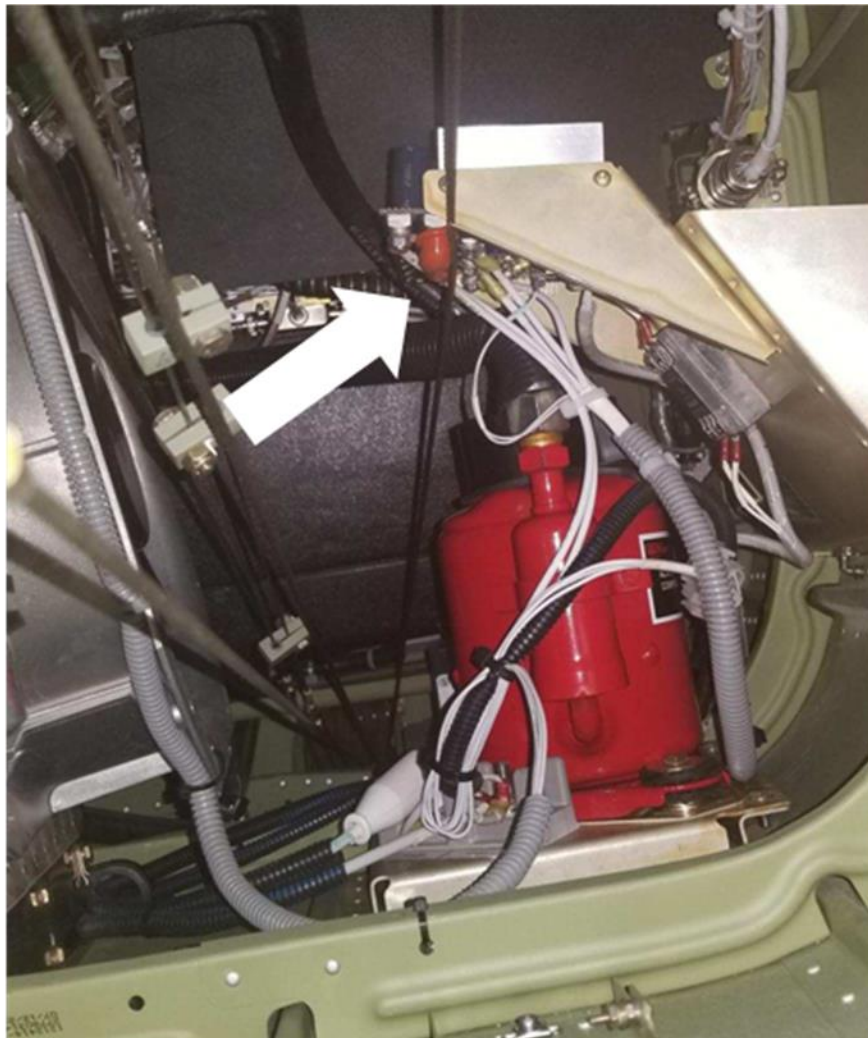
This service bulletin is being issued to notify owner/operators of Textron Aviation models 206H & T206H aircraft modified with the installation of the Kelly Aerospace Thermal Systems Air Conditioning of the possibility of rudder cable interference with the air conditioning control board. If the air conditioning inlet assembly is removed and then re-installed incorrectly the rudder cable can become caught between the AC control board and its mounting bracket which could lead to an eventual electrical short and damage to the rudder cable.

Figure 1
Improper Routing of Rudder Cable
Rudder cable is caught between mounting bracket and power stud on circuit board.

1. Remove access panel number 310AB (P/N: 1212439-1) from bottom of tailcone.
2. Inspect rudder cable routing in tailcone to verify that rudder cable is routed properly, see figure 1 for example of improper routing, see figure 2 for example of proper routing.
3. If the cable is found to be routed incorrectly, the cable routing must be corrected and the cable inspected for damage by a licensed airframe mechanic before further flight.
4. A cover for the control board has been designed to prevent the cable from being caught between the board and bracket and is available upon request from Kelly Aerospace Thermal Systems.
5. This service bulletin is recurring until AC-01995 cover has been installed, inspect per steps 1 & 2 of this procedure each time the air conditioning inlet is removed and reinstalled.

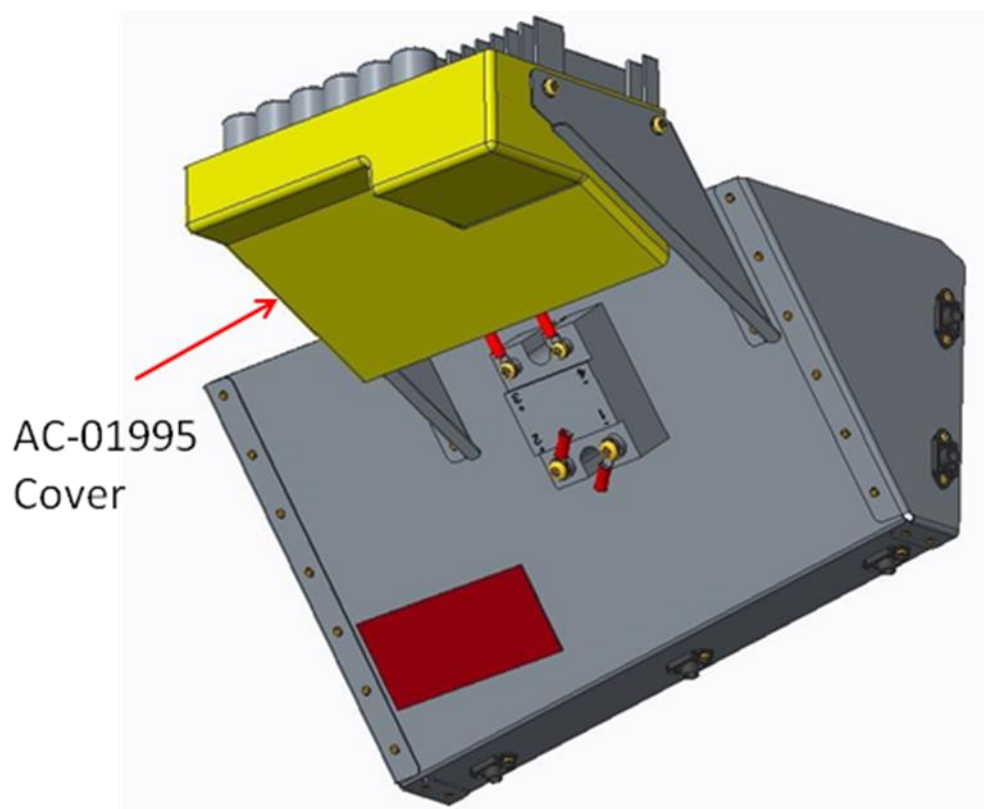
Figure 3
AC-01995 cover installed

AC-01995 cover and installation instructions are available upon request from Kelly Aerospace Thermal Systems, LLC.
